# Engineer's Foundation Evaluation

123 Sample Address, Your City, TX, 12345

On 12/31/2024 a foundation evaluation was performed at the property located at address 123 Sample Address, Your City, TX, 12345, which consists of a 2042 square-foot mobile / manufactured home structure built in 2005 with a block / pier & beam foundation.

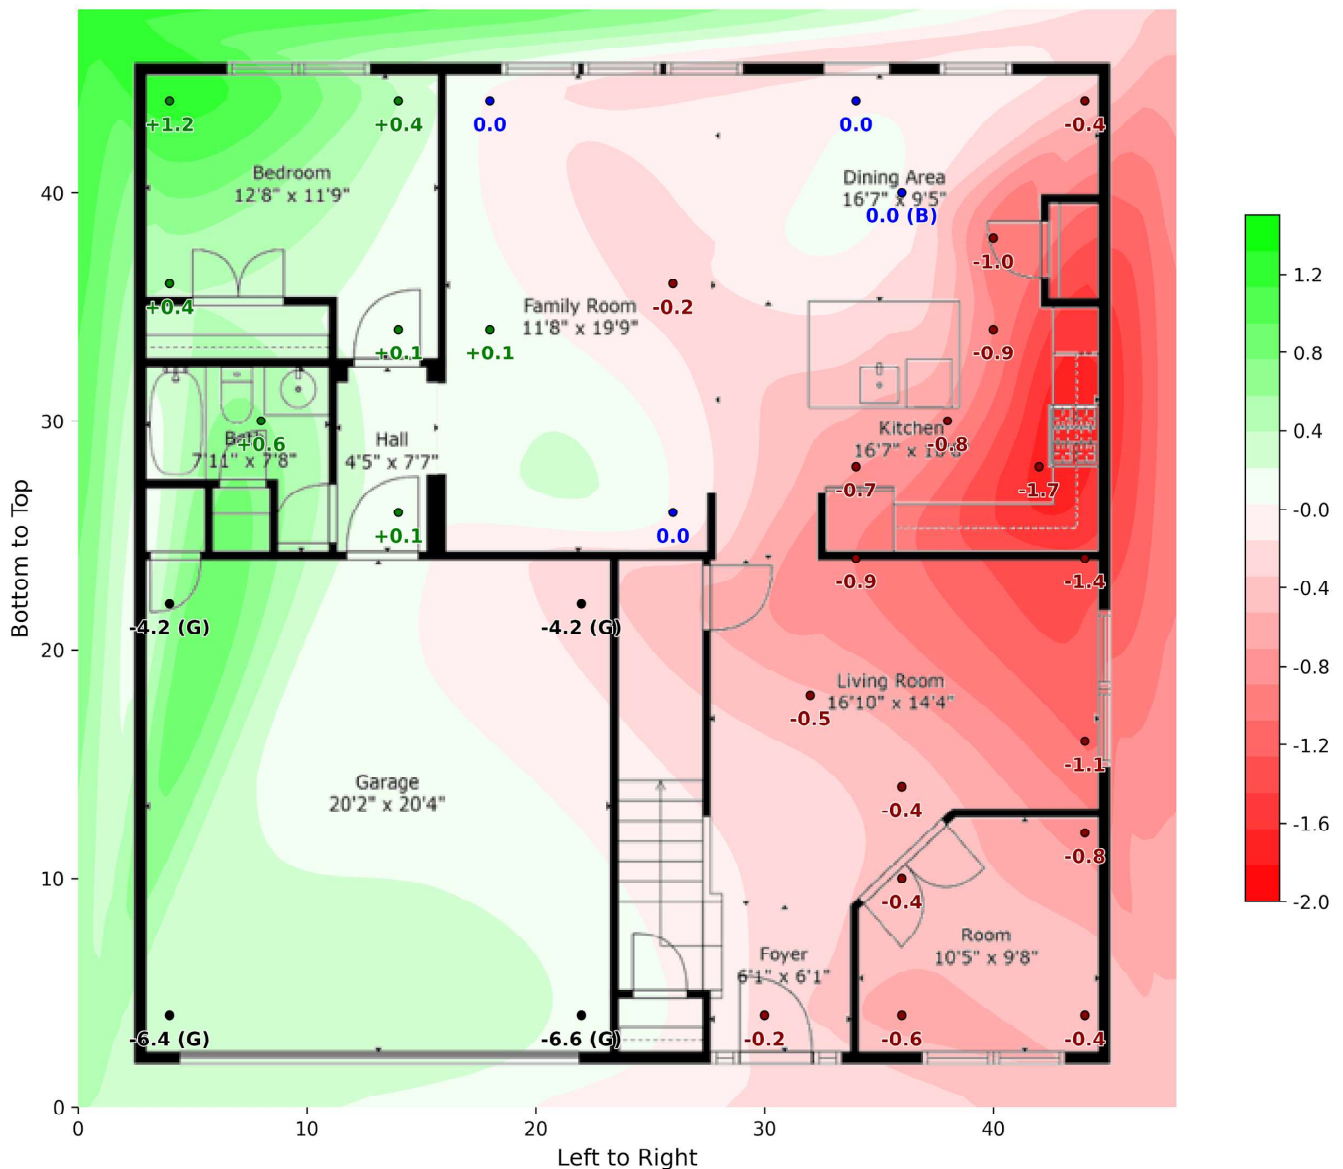
**Elevation Plot Graphic (Figure A)**

The elevation plot resulted in the graphic as depicted above in Figure A. The red-points and areas are elevation measurements that were lower than the base station elevation (0.0). The green-points and areas are elevation measurements that were higher than the base station elevation (0.0). The blue-points (and white areas) are equal to the base station elevation (0.0). The maximum elevation point was determined to be 1.2 inches and the minimum was -1.7 inches, resulting in an elevation difference of 2.9 inches of difference across the structure.

As documented above, the maximum elevation point of this structure was determined to be 1.2 inches and the minimum was -1.7 inches, resulting in an elevation difference of 2.9 inches of difference across the structure. The elevation deflection across an entire structure should remain within 0.5 to 1-inch depending on the age of the structure. Measured differences approaching 2-inches are a sign of foundation fatigue. The maximum allowable elevation difference is subjective, depending on other factors such as the visual condition and age of the structure (20 year(s) old).

Based on observed elevations of the foundation from the elevation plot, the structure cannot be considered fully stable. Elevation differences do not fall within industry standards or tolerable limits. These findings indicate that the foundation does not have consistent and uniform elevation demonstrating continued movement of the foundation.

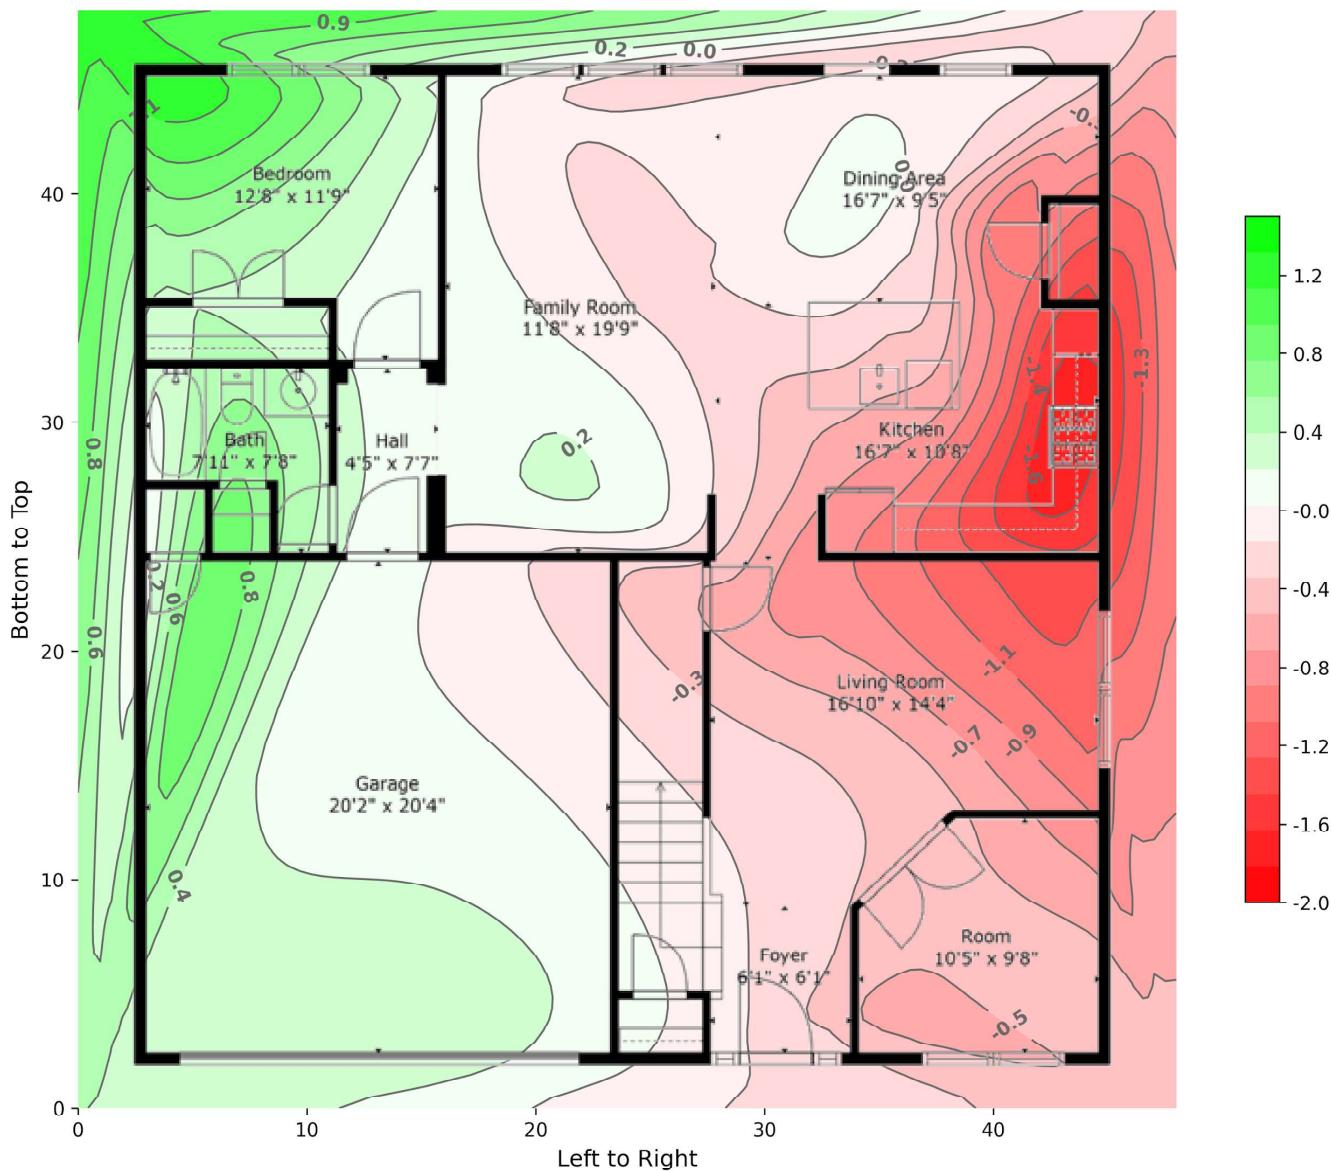
**Mesh Contour Graphic (Figure B)**

The mesh contours graphic depicted above in Figure B is similar to the elevation plot. The red, green, and white areas depict areas that are lower, higher, and equal to the base station elevation (0.0). The contour intervals are labeled.

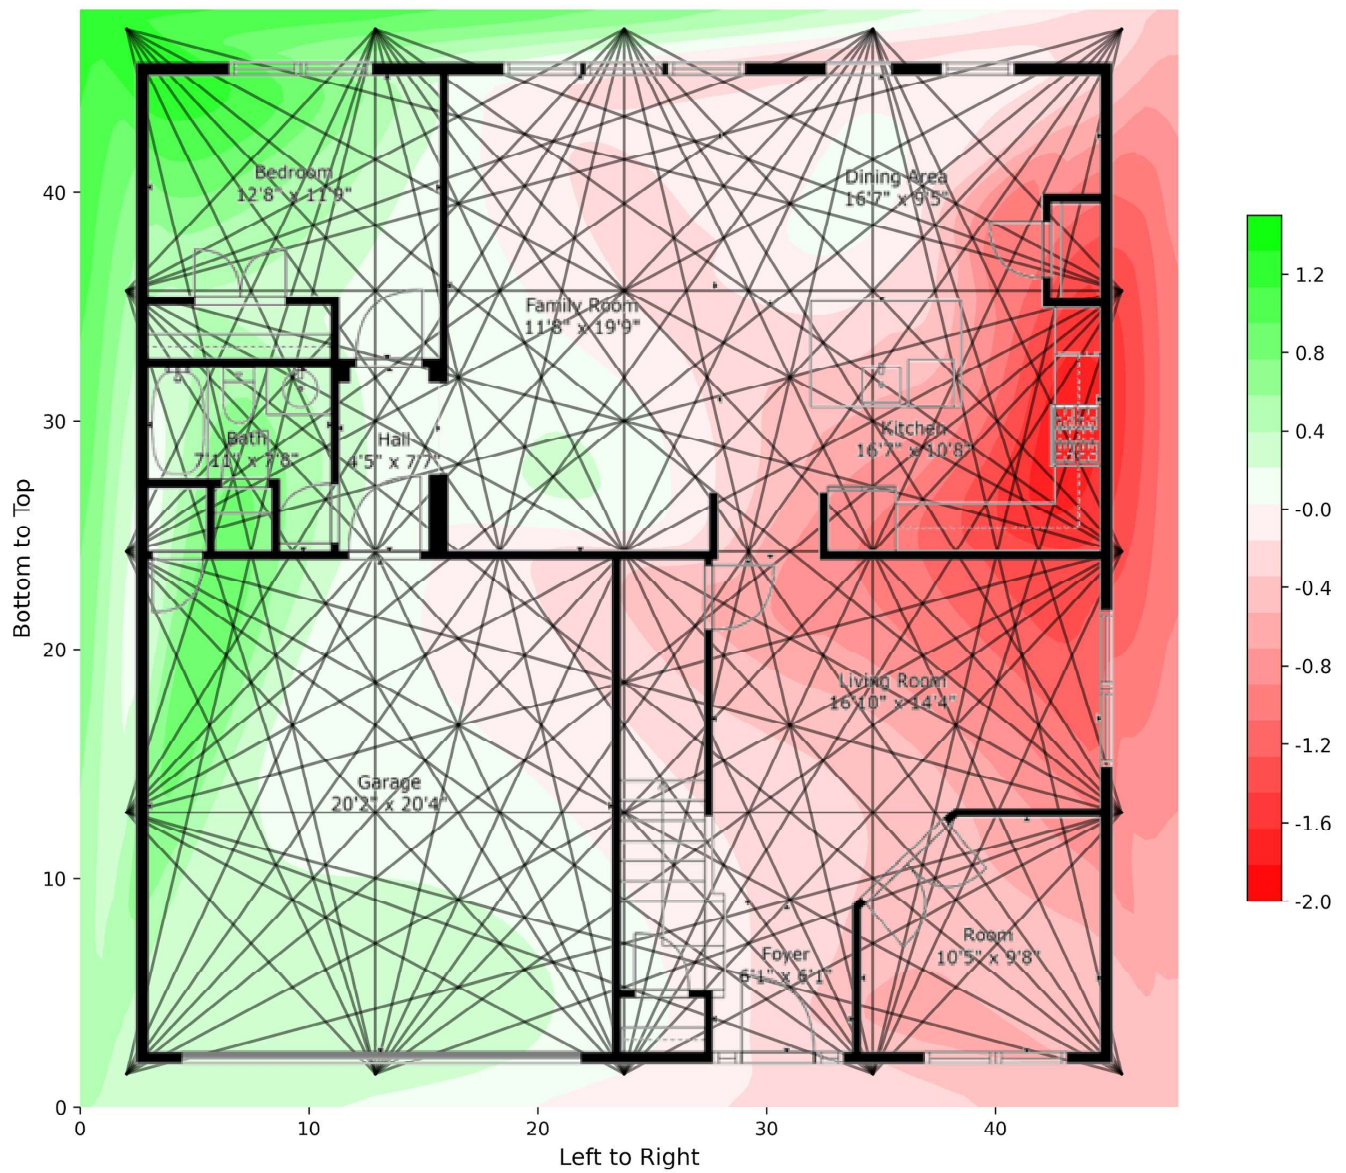
**All Profiles Graphic (Figure C)**

Below is a graphic that shows the locations of deflection and tilt profiles that were calculated. The total profiles calculated was 79 with a total usable profiles (above the effective length threshold) of 76.

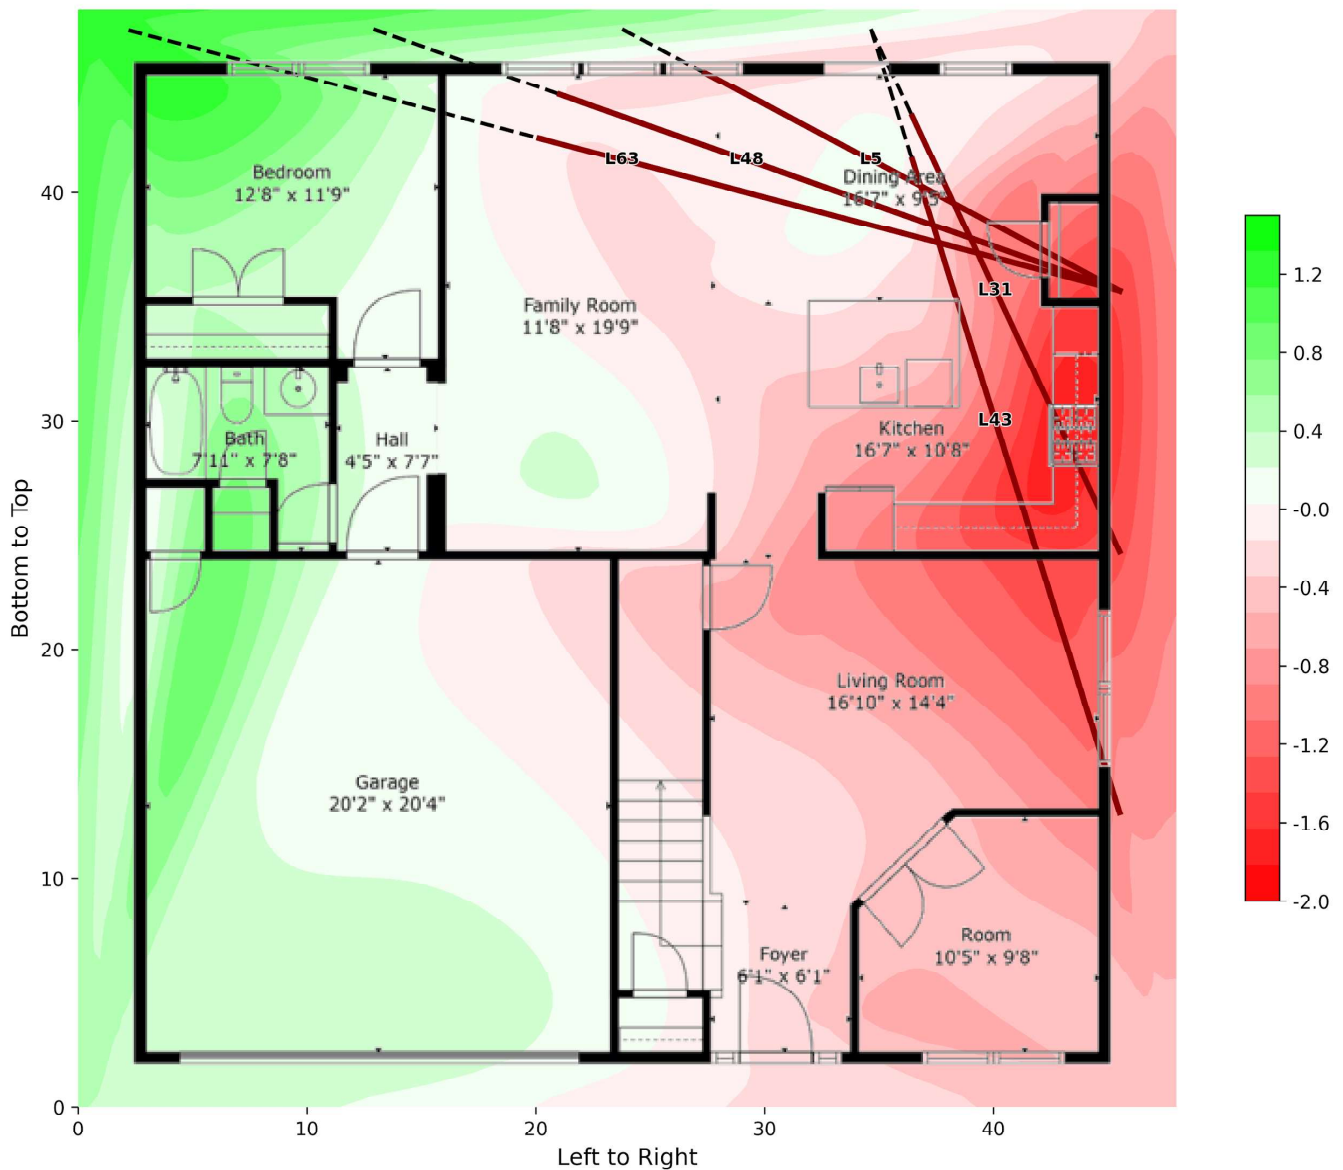
**Deflection Failures Graphic (Figure D)**

The above Figure D shows deflection failures along the foundation. Deflection failures can be considered localized failures in (sometimes) isolated portions of the foundation. The profile lines that were calculated are represented by a dashed black line and the areas that the deflection failures occur are represented by a dark red line segment. Of the 76 deflection profiles calculated, 5 profile failures were identified.

Deflection failures can be considered localized failures of the foundation in (sometimes) isolated portions of the foundation. Of the 76 deflection profiles calculated, 5 failures were identified.

Deflection failures are above standard acceptable limits; they exceed industry-standard thresholds and the structure should be considered actively moving/settling in areas where deflection failures are occurring.

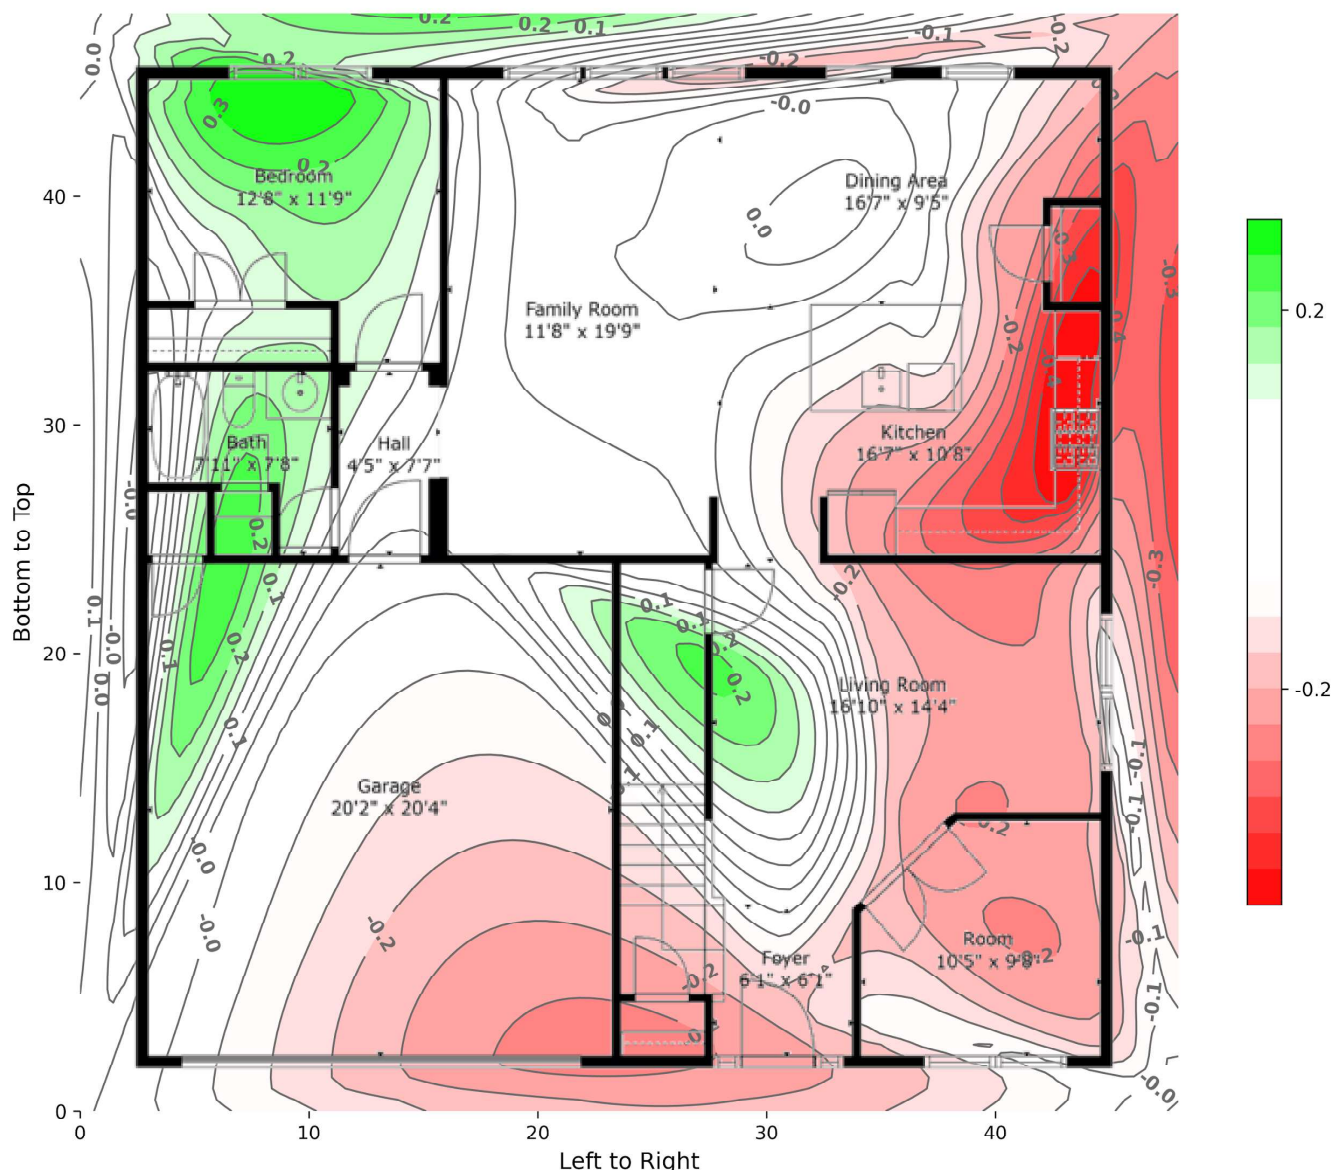
**Elevation Plot Difference Graphic (Figure F)**

The mesh contour graphic above in Figure F shows areas in red that are lower than the baseline elevation plot and areas of green that are higher than the baseline elevation plot (from the provided drawing completed in 1998). The darker the color (both red and green) the larger/smaller the elevation differences.

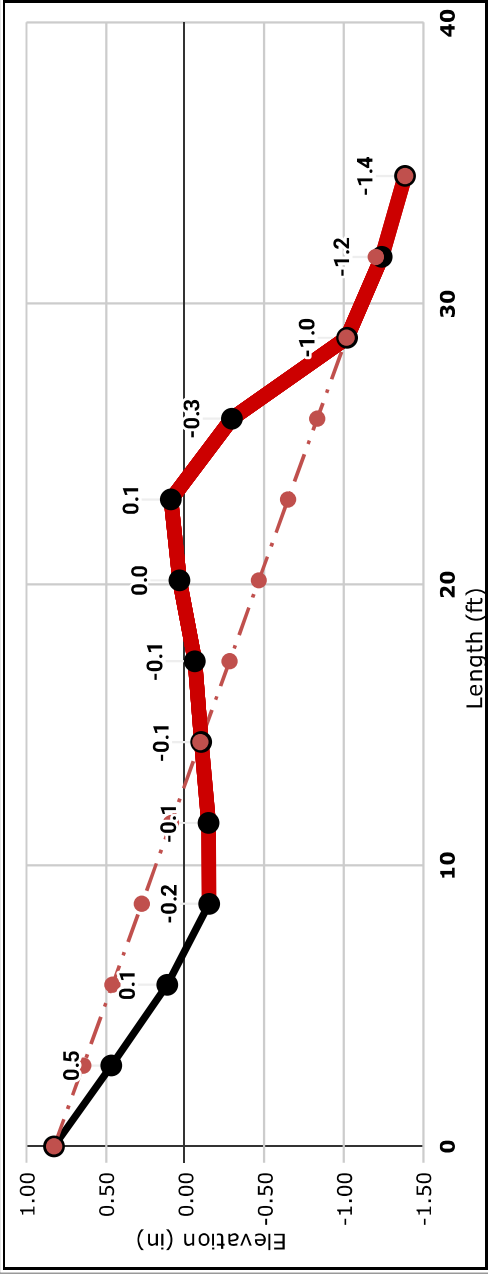
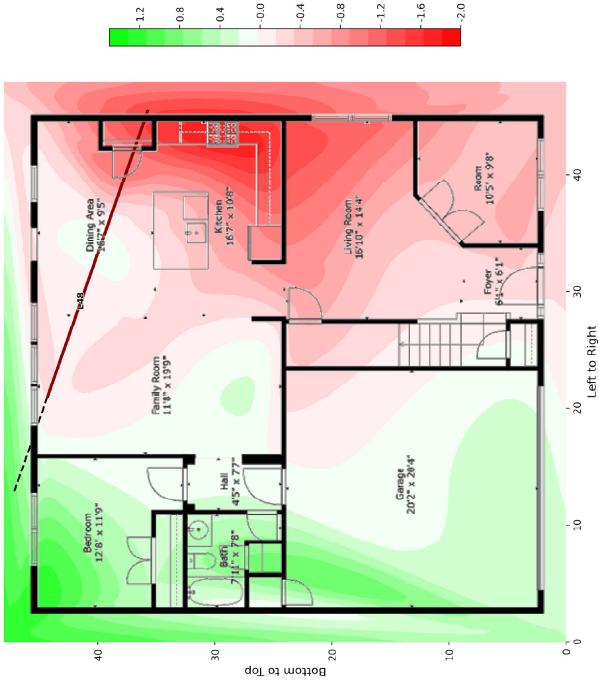
Exhibit A: Identified Deflection/Tilt Failure (L48)

| Performance Output | | | | | | |
|---|---|---|---|---|---|---|
| Deflection 1 (using k) | FAIL | L / 281 | EXCEEDS THE kL/360 (L/340) LIMIT BY 21% | 4 | 9 | 11 |
| Deflection 2 (using k) | FAIL | L / 281 | EXCEEDS THE kL/360 (L/340) LIMIT BY 21% | 5 | 9 | 12 |
| Deflection 3 (using k) | FAIL | L / 300 | EXCEEDS THE kL/360 (L/340) LIMIT BY 13% | 4 | 9 | 12 |
| Deflection 4 (using k) | FAIL | L / 323 | EXCEEDS THE kL/360 (L/340) LIMIT BY 5% | 5 | 9 | 13 |
| Deflection 5 (using k) | FAIL | L / 326 | EXCEEDS THE kL/360 (L/340) LIMIT BY 4% | 6 | 9 | 13 |
