# Engineer's Foundation Evaluation

123 Sample Address, Your City, TX, 12345

On 12/31/2024 a foundation evaluation was performed at the property located at address 123 Sample Address, Your City, TX, 12345, which consists of a 2042 square-foot mobile / manufactured home structure built in 2005 with a block / pier & beam foundation.

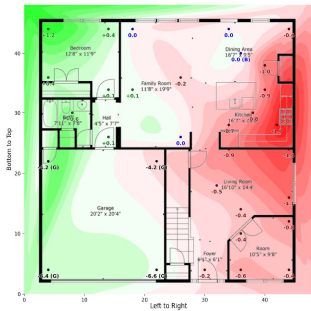
Figure A

This evaluation indicates clear signs of foundation issues. Calculations were not found to be within industry standard limits. Remedial measures are required to bring the foundation to a more level condition. It is recommended that foundation stabilization be completed as soon as possible, if possible within the next year. In addition, visual deficiencies noted should be resolved after foundation improvements have been completed. We also recommend you perform another house elevation plot after repairs have been completed to memorialize the elevation changes. Due to the nature that foundation work is recommended, it is imperative that you read the entire report in detail for a comprehensive explanation of this conclusion.
